Burner Tests on Defective Thermal Protection Systems

Transportation Development Centre
Transport Canada

Department of Mechanical Engineering
Queen's University
Kingston, Ontario

March 2003

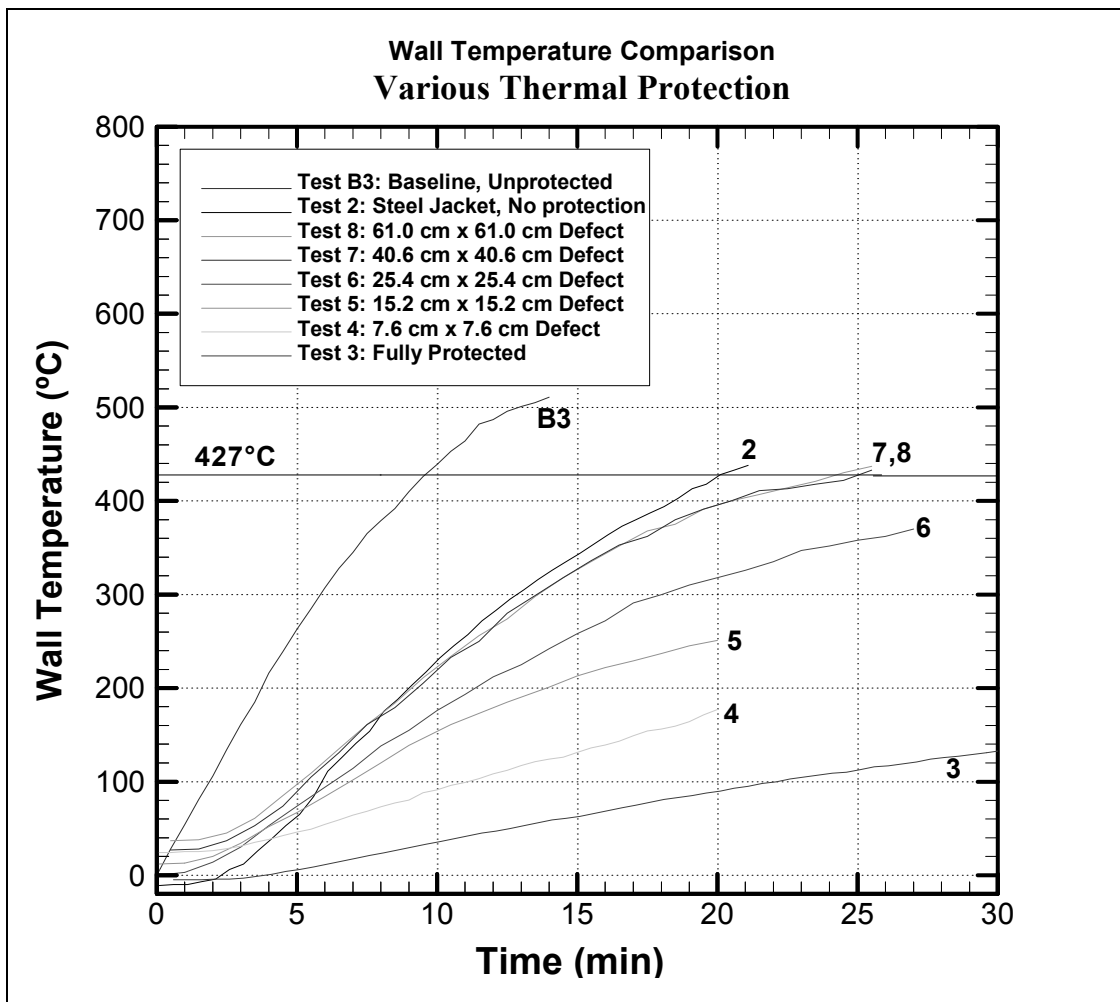
Figure 1: Wall Temperature versus Time for Various Defect Sizes

When the tank wall is exposed to the engulfing fire, the wall temperature is a function of the defect size. As the defect gets larger, the heat transfer, the temperature rise rate, and the maximum temperature of the tank wall in the defect area gets larger, as shown in Figure 1. For a defect smaller than 0.4 m, the surrounding thermal protection material provides a significant cooling effect for the defect area. For a defect larger than 0.4 m, the measured peak wall temperature at the centre of the defect is not affected significantly by the surrounding protected material. It can be seen from Figure 1 that defects larger than 40 cm gave about the same peak wall temperature as the case where only the steel jacket was present.

It is recommended that a thermal protection defect with average defect dimension of 40 cm or greater be considered to be a very significant defect.

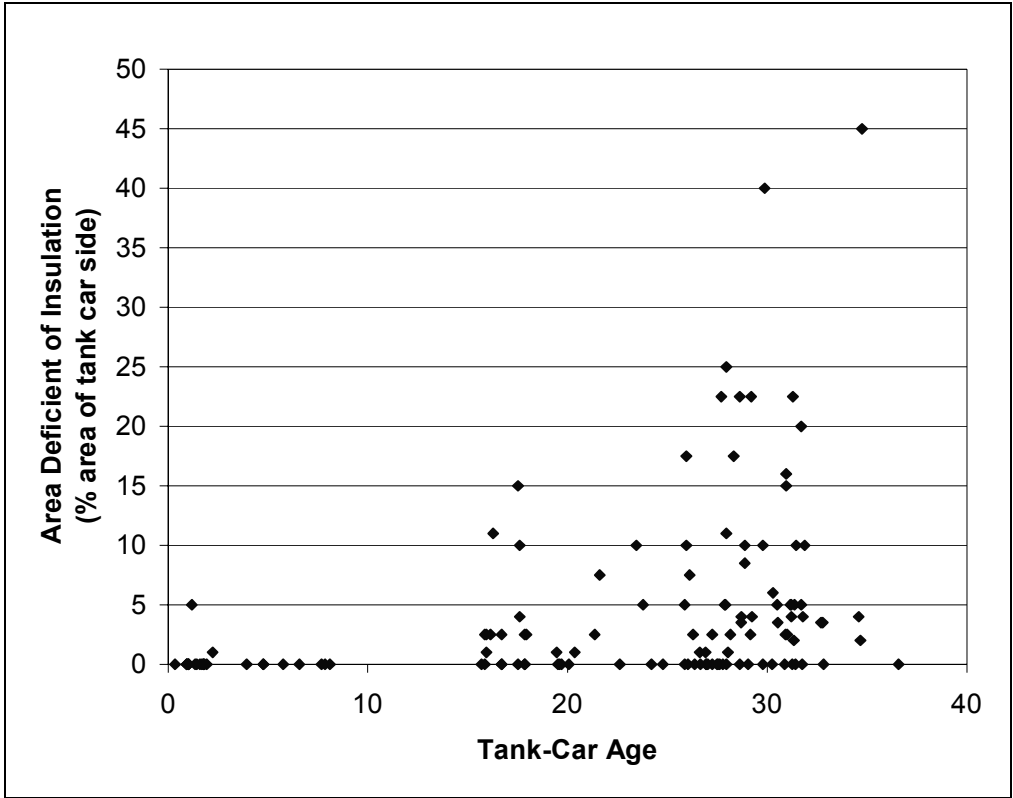
Figure 1: Defective Area on Tank Side versus Tank Age (Birk and Cunningham, 2002)

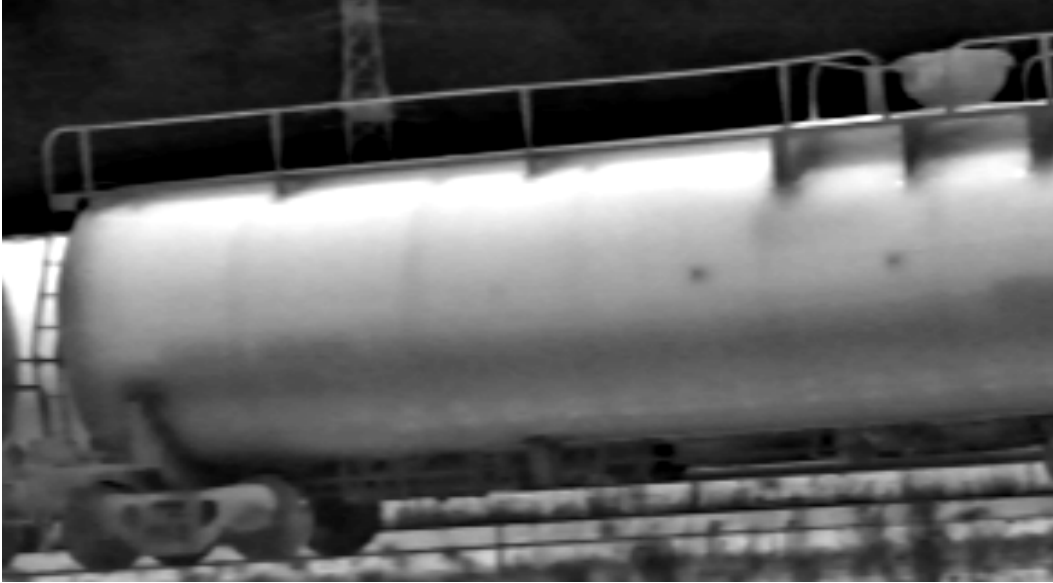
Figure 3: Tank-Car with No Thermal Protection Deficiencies (Thermal Image)

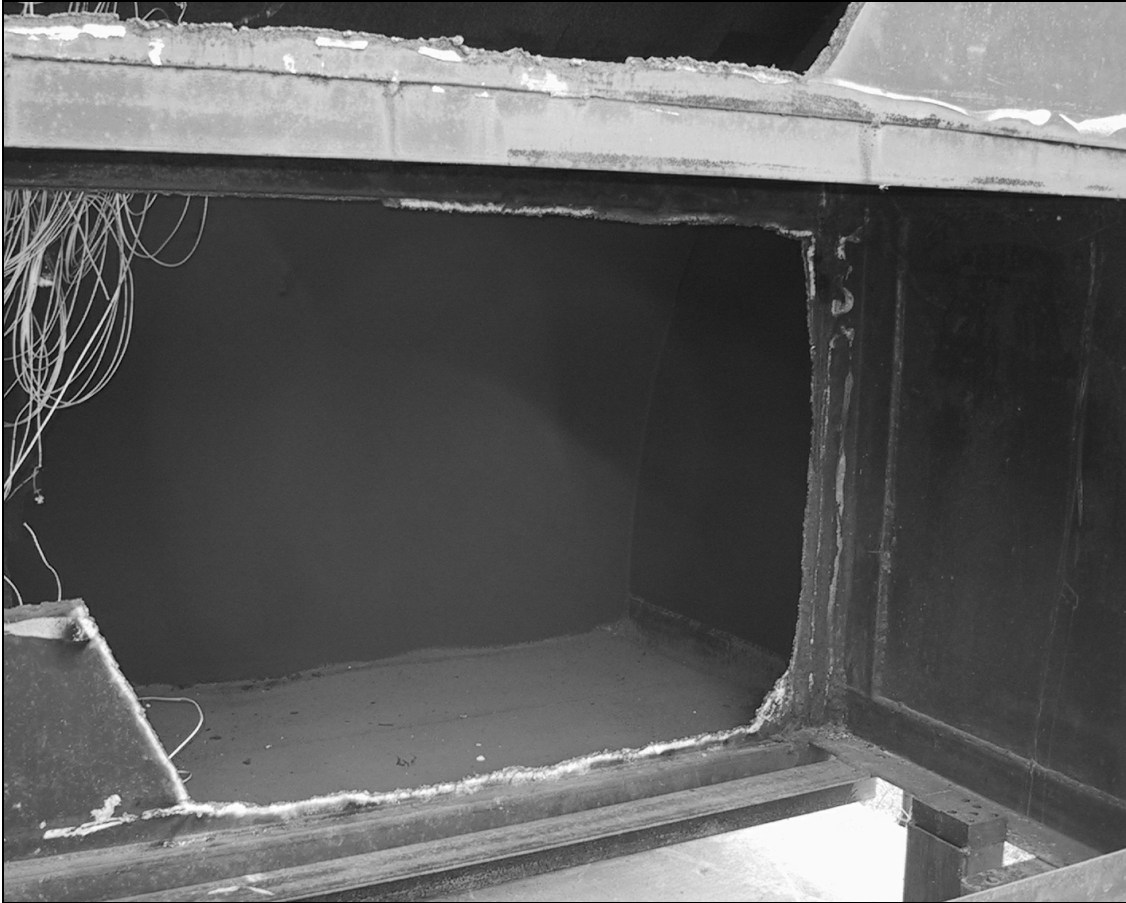
Figure 6: Back of Tank Wall

1. The front and back of the tank wall were painted flat black to give a consistent finish and high emissivity ($e = 0.90-0.95$).
2. The existing burner mounting system was removed and replaced with a burner rack, as can be seen in Figure 4 and Figure 5.
3. Part of the steel structure was cut away to expose the back wall and allow access for the thermal imager. This is shown in Figure 6.

- Holes were drilled through the tank wall to allow either for the addition of 13 mm (0.5 in.) spacers or for clamping the steel jacket against the tank wall. Most tests required the 13 mm (0.5 in.) spacers to keep the jacket from crushing the 13 mm (0.5 in.) thick insulation. If the test required crushed insulation, however, the spacers were removed and the jacket was bolted to the tank wall.

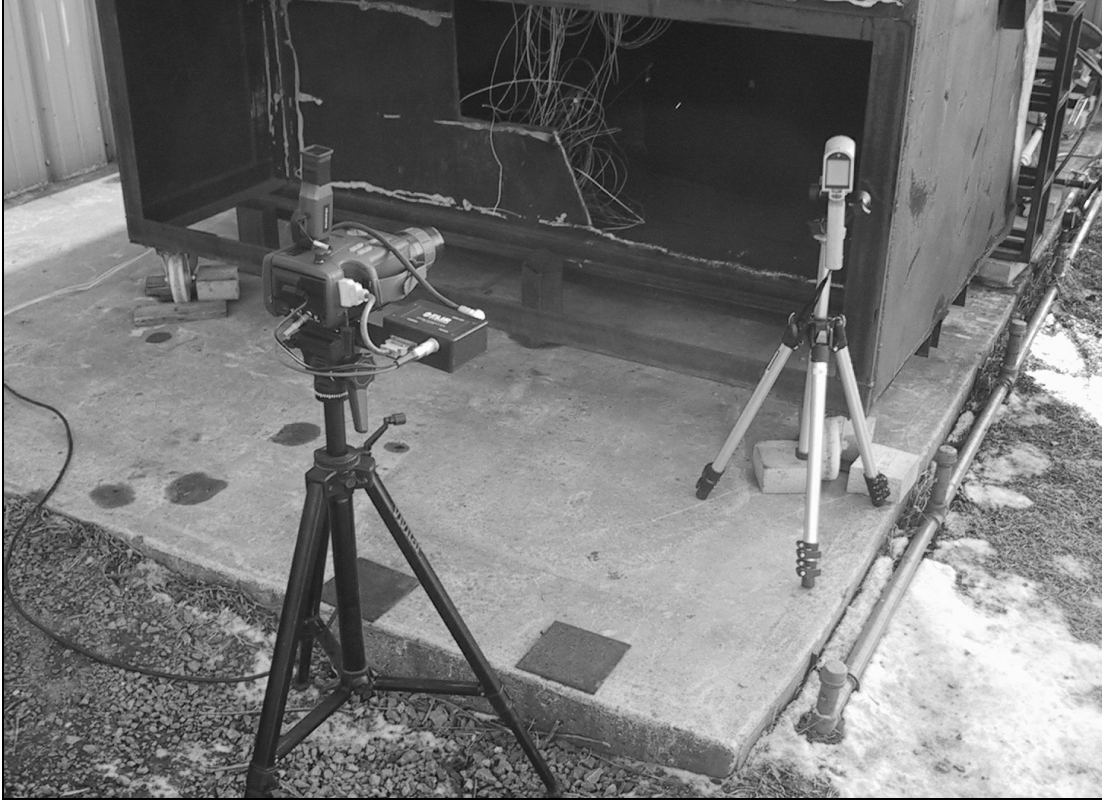
Figure 10: IR Camera (FLIR ThermaCAM SC 1000) and IR Thermometer (Raytek MX4)

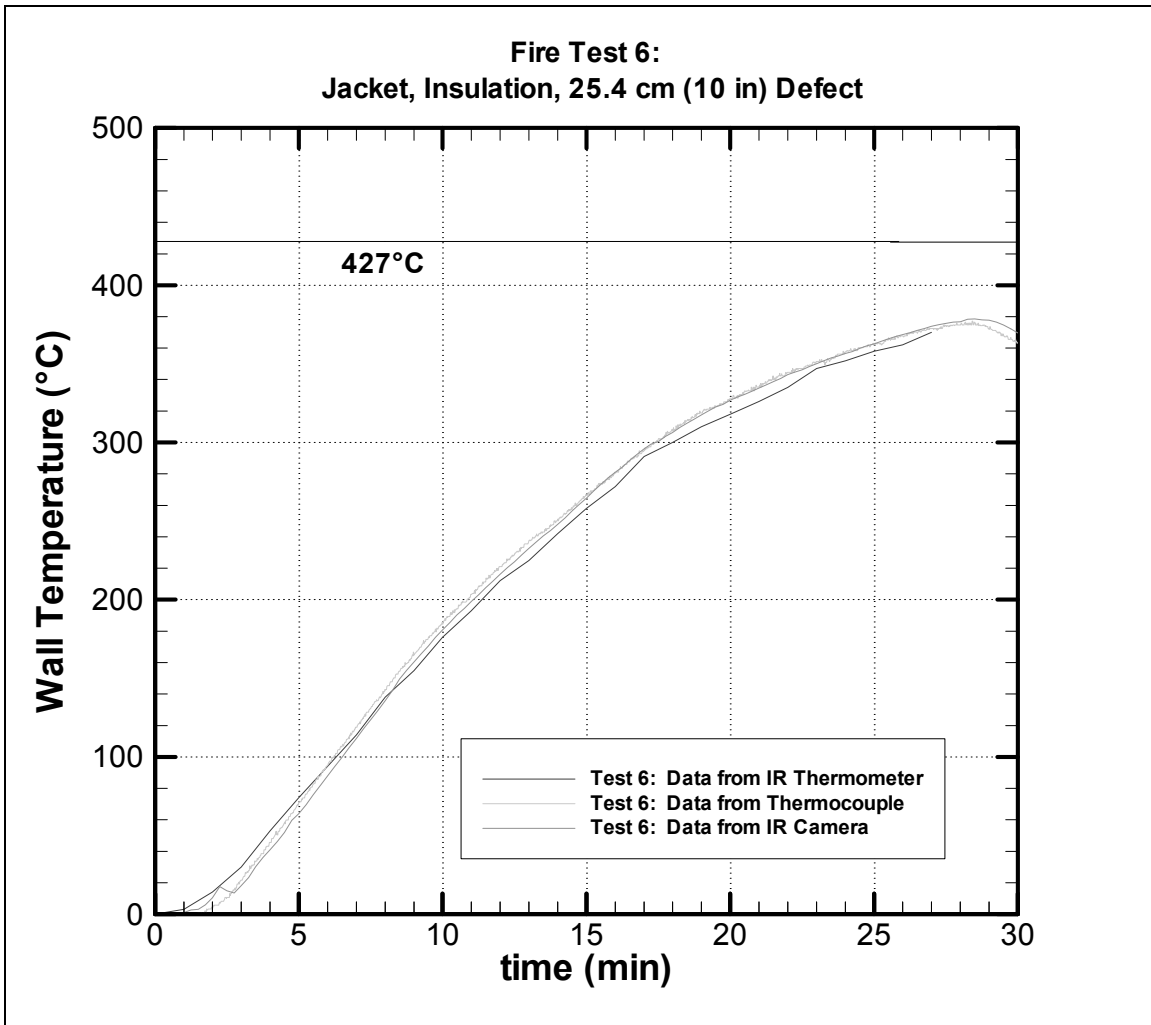
Figure 12 shows a sample plot from one of the tests. It shows the maximum wall temperature versus time using all three measuring methods. The temperature data from the thermocouple, IR thermometer, and IR camera are in excellent agreement.

Figure 12: Maximum Wall Temperatures from Fire Test 6

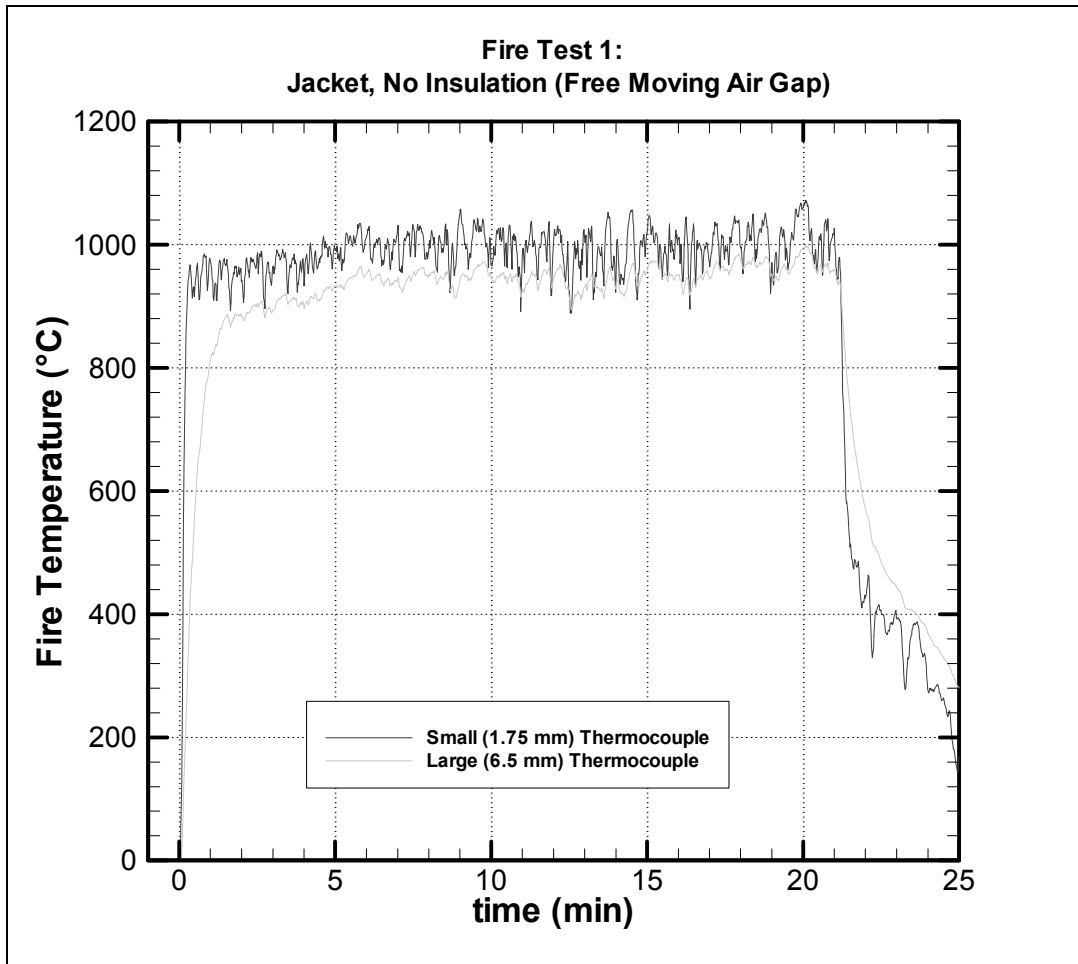
The difference between the readings is due to thermocouple errors. To minimize conduction error, the thermocouples were located several centimetres into the flame to minimize the temperature gradient at the tip. Because of the nature of fire, thermal gradients were present and conduction errors occurred. The thermocouples were also inserted deeper into the fire to minimize the radiation errors. Because the flames were not totally opaque, there was radiation exchange between the probe and the environment, and radiation errors still occurred. The large probe obviously has a larger surface and cross-sectional area and thus was more affected by radiation and conduction errors. The large thermocouple thus gave a lower temperature. See Appendix A for further details on radiation error.

Figure 13: Fire Temperature from Fire Test 1

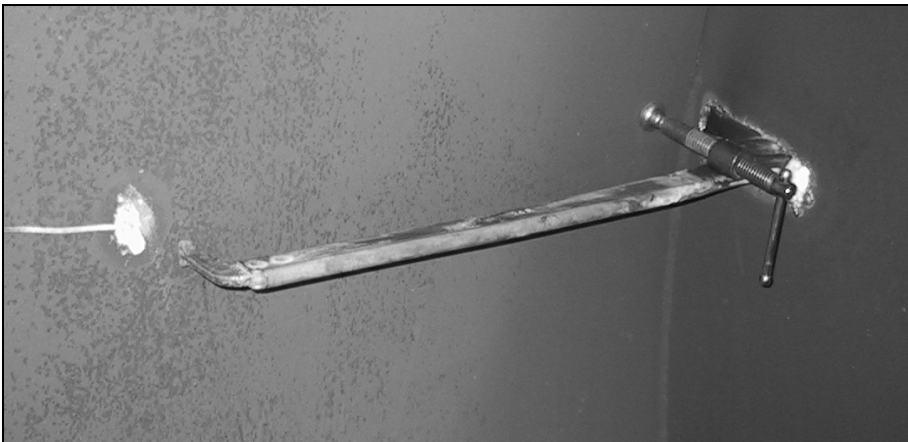
Figure 15: Back Side of Clamped Wall – Clamped at Thermocouple Location (Test 12)

In pressed jacket tests, the jacket was bolted to the tank wall around the jacket perimeter. This allowed the jacket and the wall to come into contact in several locations and left a very thin air gap for the no insulation test (Test 9). Figure 14 shows this sort of set-up. The set-up was identical in the clamped jacket test (Test 12), except vice-grips were used to clamp the jacket to the tank wall near the thermocouple position. Figure 15 shows the clamp positioned on the tank viewed from the back wall.

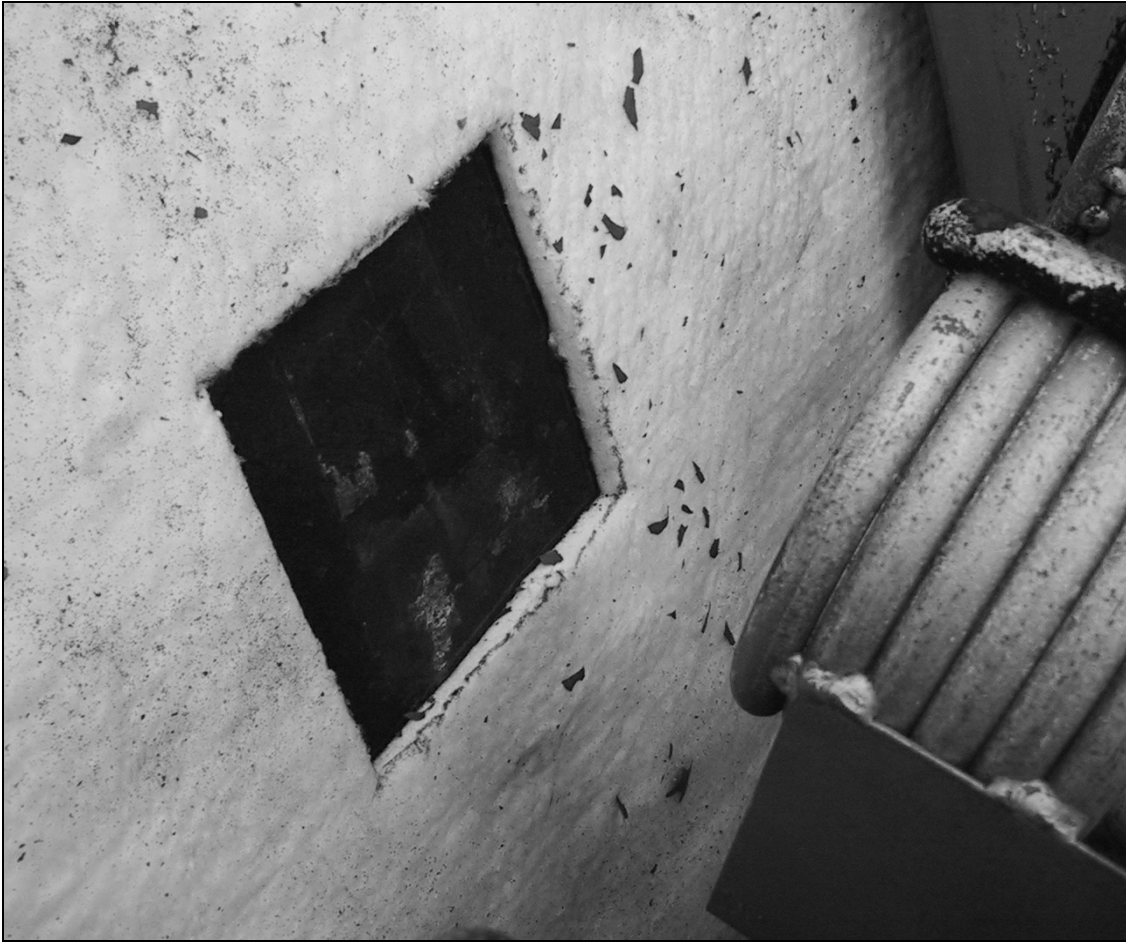
Tests 4, 5, 6, 7, 8, and 11 were run with a square defect cut out of the insulation. The size of the defect listed in Table 4 indicates the length of one side of the square defect. The defect was positioned so that the thermocouple was in the centre of the defect. Figure 16 shows the 15.2 cm defect before the jacket was placed over it.

Figure 16: 15.2 cm Defect, Jacket Removed (Test 5)

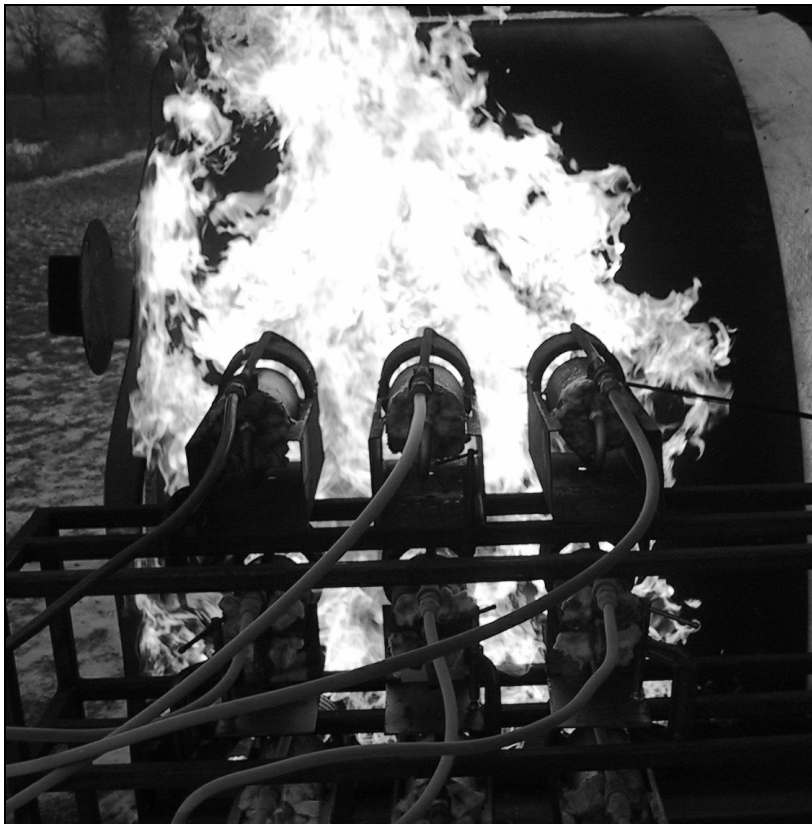
Figure 17: Front View of Fire Engulfment

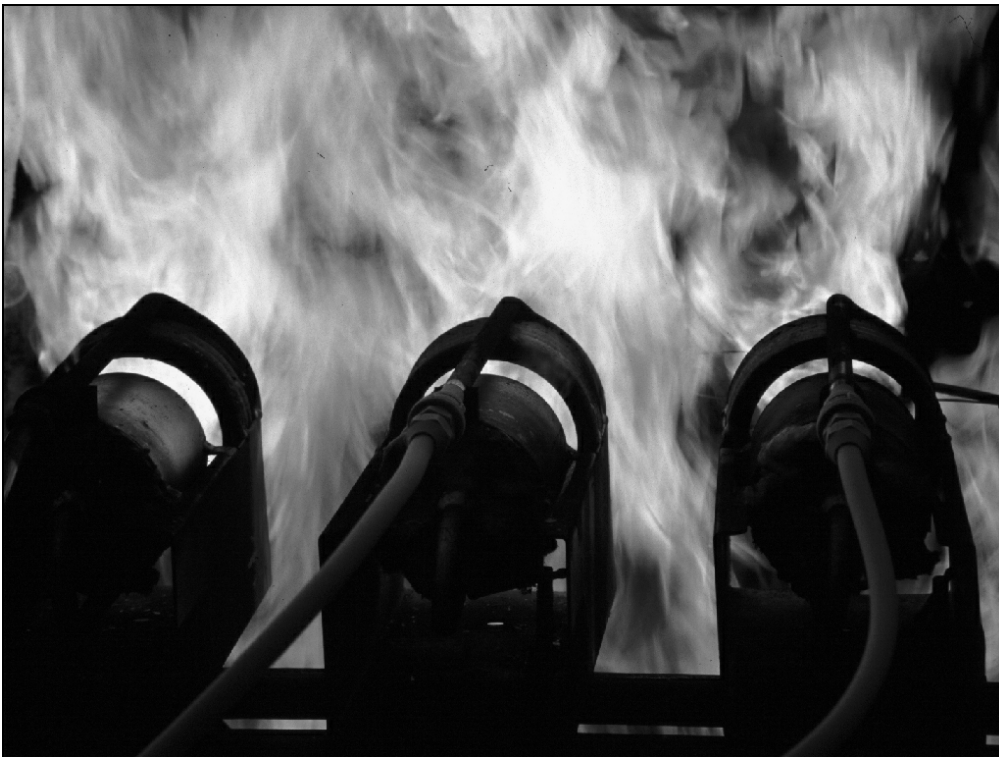
Figure 19: Close Up of Sooty, Luminous Flame

The flames were typically quite sooty, leaving a fine black coating on the tank jacket during the tests. Black specks of soot were common in the plume. In many cases, the distinctive smell of unburned hydrocarbons was present.

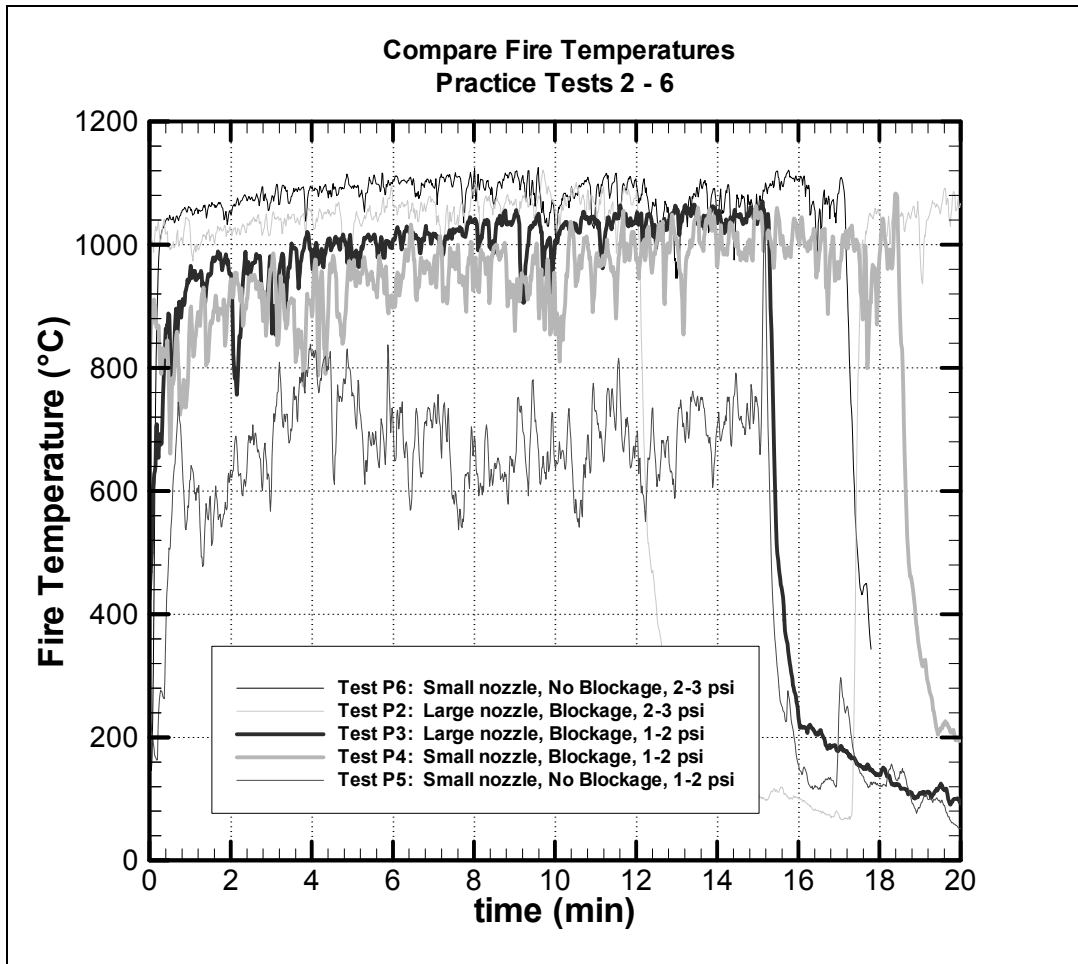
Figure 21: Fire Temperatures from Pre-test Fire Tests

Several parameters were varied throughout the pre-test fire tests, which allowed for an interesting variety in fires. The data presented in Table 5, Figure 20 and Figure 21 shows the effect of the different parameters. Figure 20 and Figure 21 show the same trends, because without thermal protection, a higher fire temperature will result in better heat transfer and higher wall temperatures.

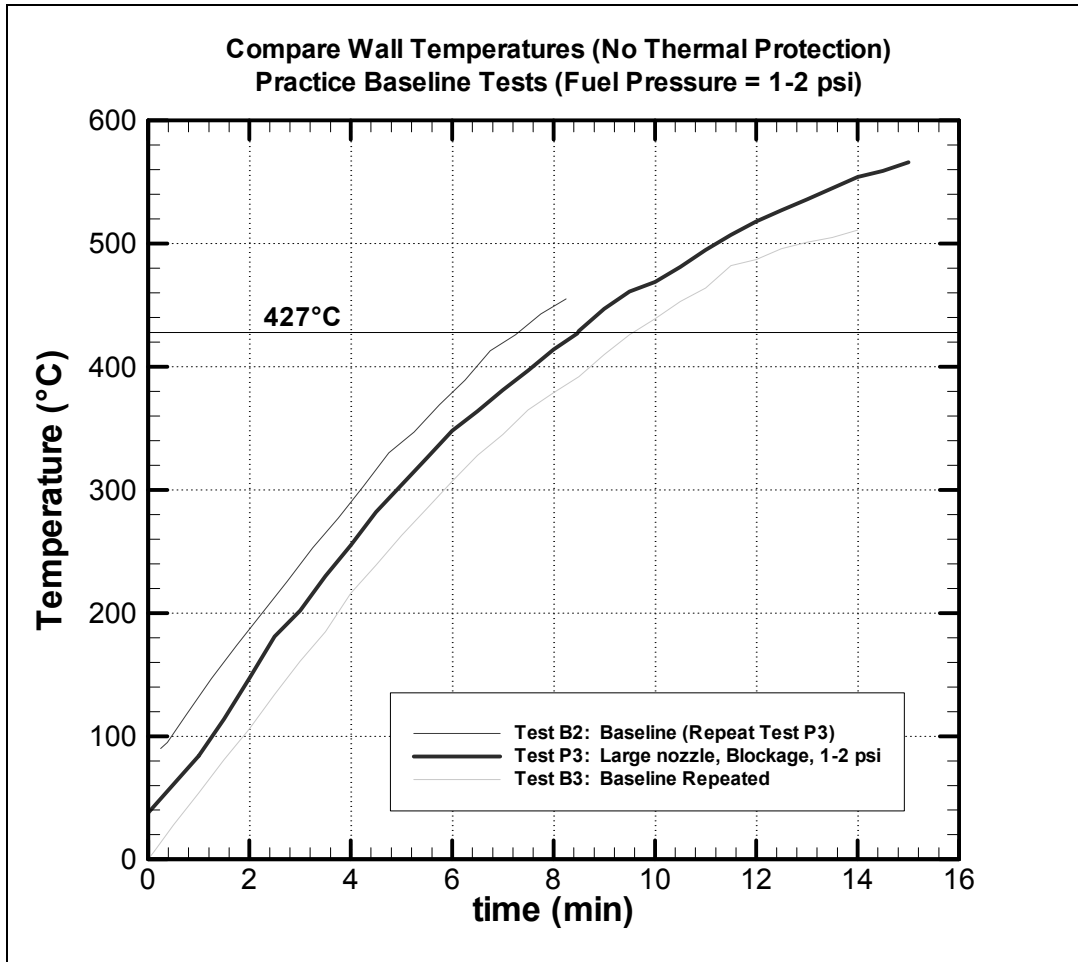
Figure 22: Baseline Tests to Check for Repeatability

The three baseline tests were designed to test the fire's repeatability. Figure 22 shows the wall temperature for Test P3 and the two tests that were designated to be a repeat of Test P3. As desired, the three curves are almost identical, except for the initial starting temperature.

The fire conditions had to be repeatable, as well as credible. Figure 22 and Figure 23 can be used to prove the fire's repeatability.

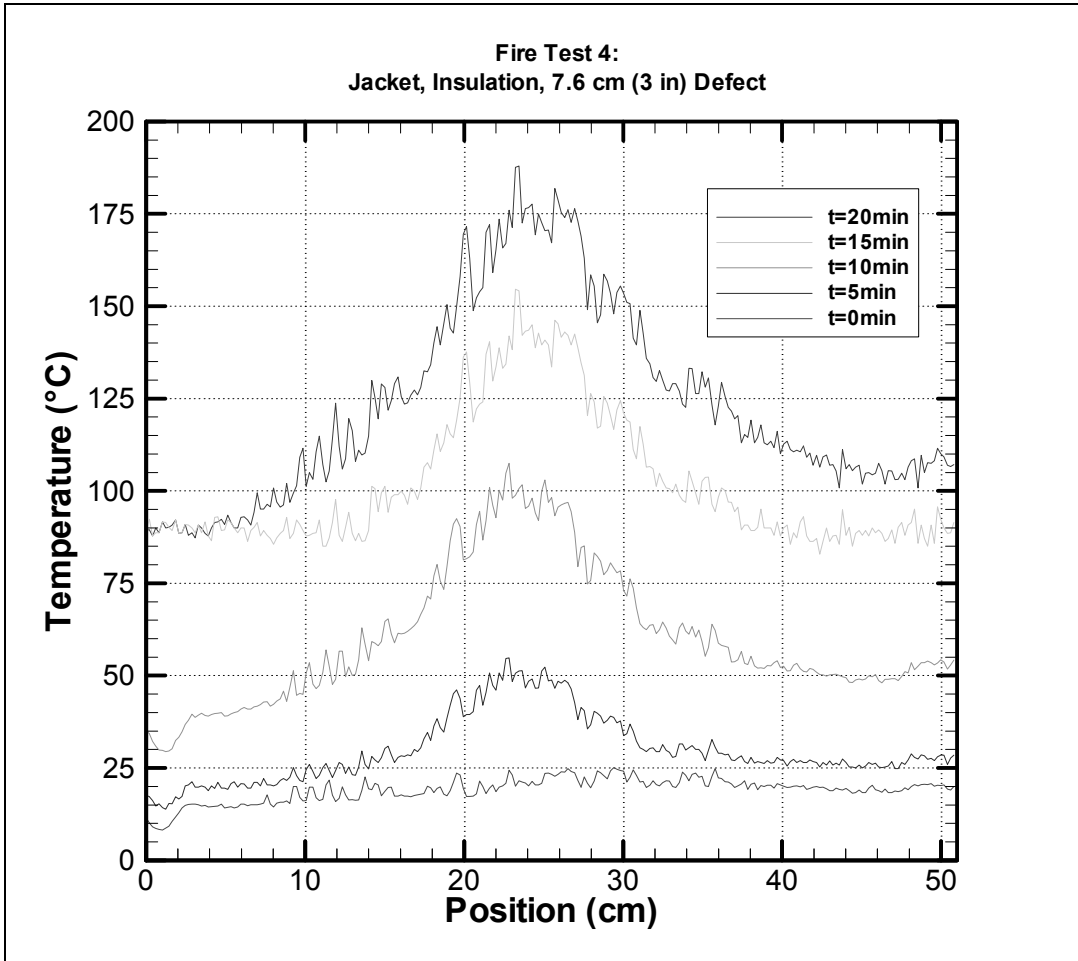
Figure 26: Temperature Profile Across Defect at Various Times During Test 4

Figure 26 shows temperature profiles across the defect at various times during Fire Test 4. As time goes on, the maximum temperature gets higher and the temperature gradients get larger. It is anticipated that if the fire test were allowed to continue, the peak temperature would eventually reach equilibrium and level off, and the gradients would decrease as the “hot spot” gets wider.

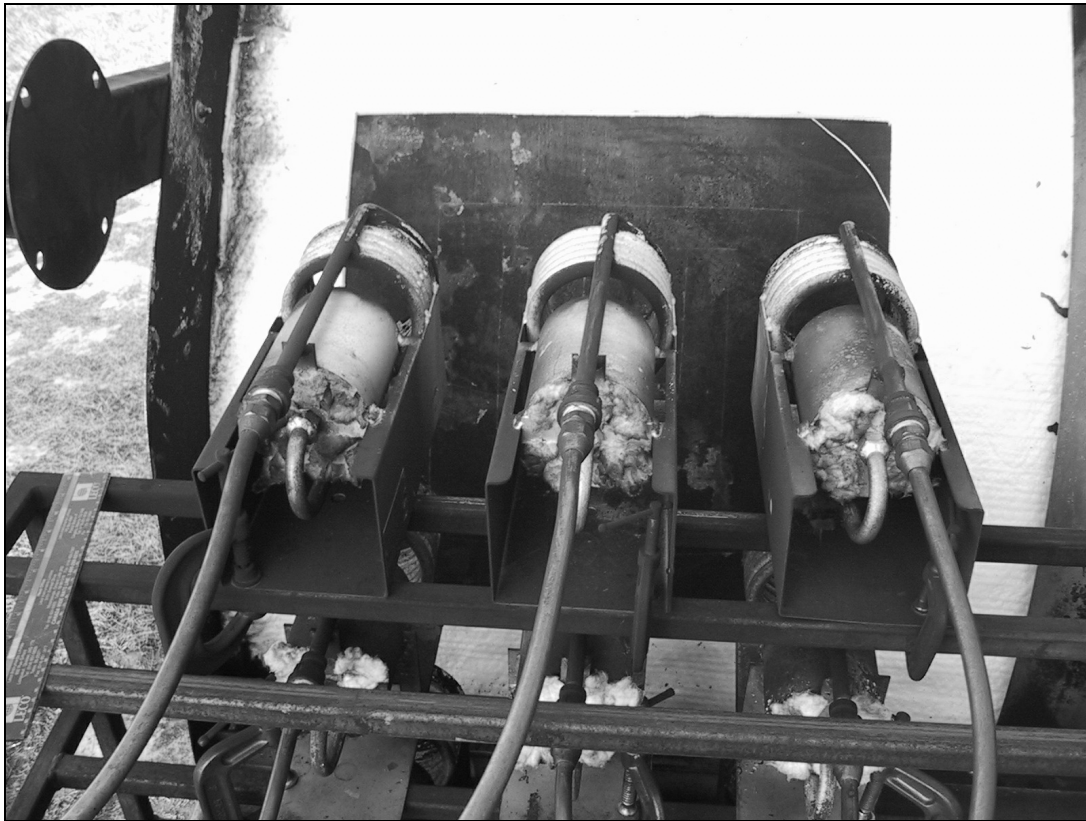
Figure 30: 61.0 cm Defect, Jacket Removed for Photo (Test 8)

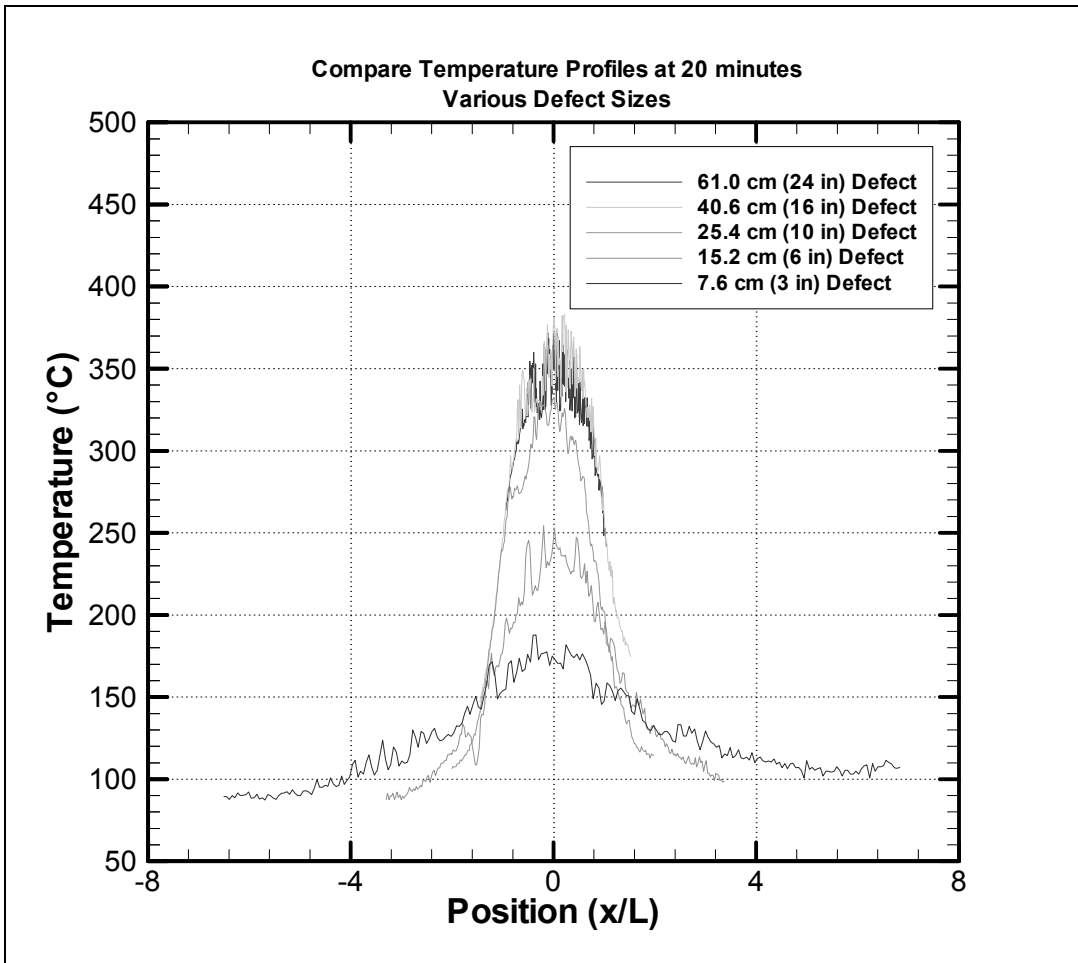
The shape of the temperature profile also differs with defect size, as shown in Figure 31. Not only is the peak temperature higher with a larger defect, but the range of temperatures (max-min) is higher as well. This suggests that the difference between the maximum and average temperature will get greater as the defect increases in size.

Figure 31 shows a plot of the non-dimensional temperature profiles at 20 minutes. Notice that the non-dimensional width of the “hot spot” is consistent through all the tests at 20 minutes. Also notice that, as the defect gets larger, the profiles start looking identical. As suggested earlier, at a certain size of defect, the size no longer matters very much. This size has been shown to be about 0.4 m.

Figure 31: Various Non-dimensional Temperature Profiles at 20 minutes (L=half length of defect)

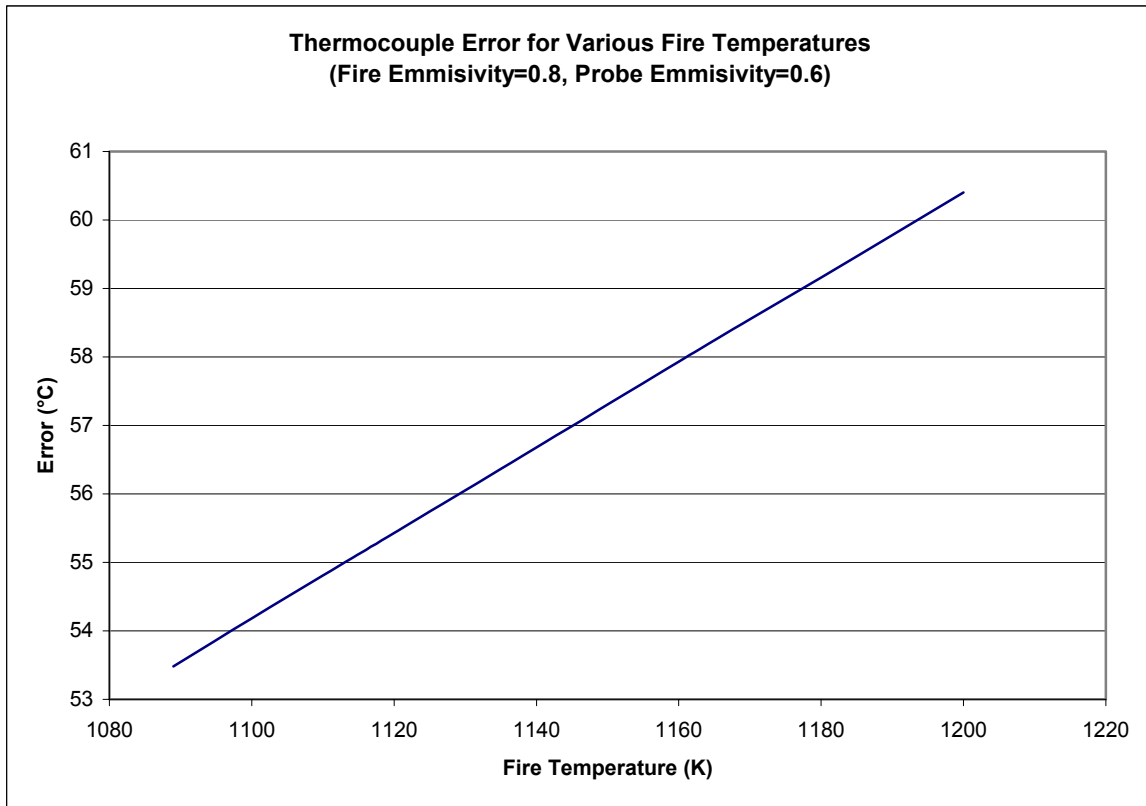
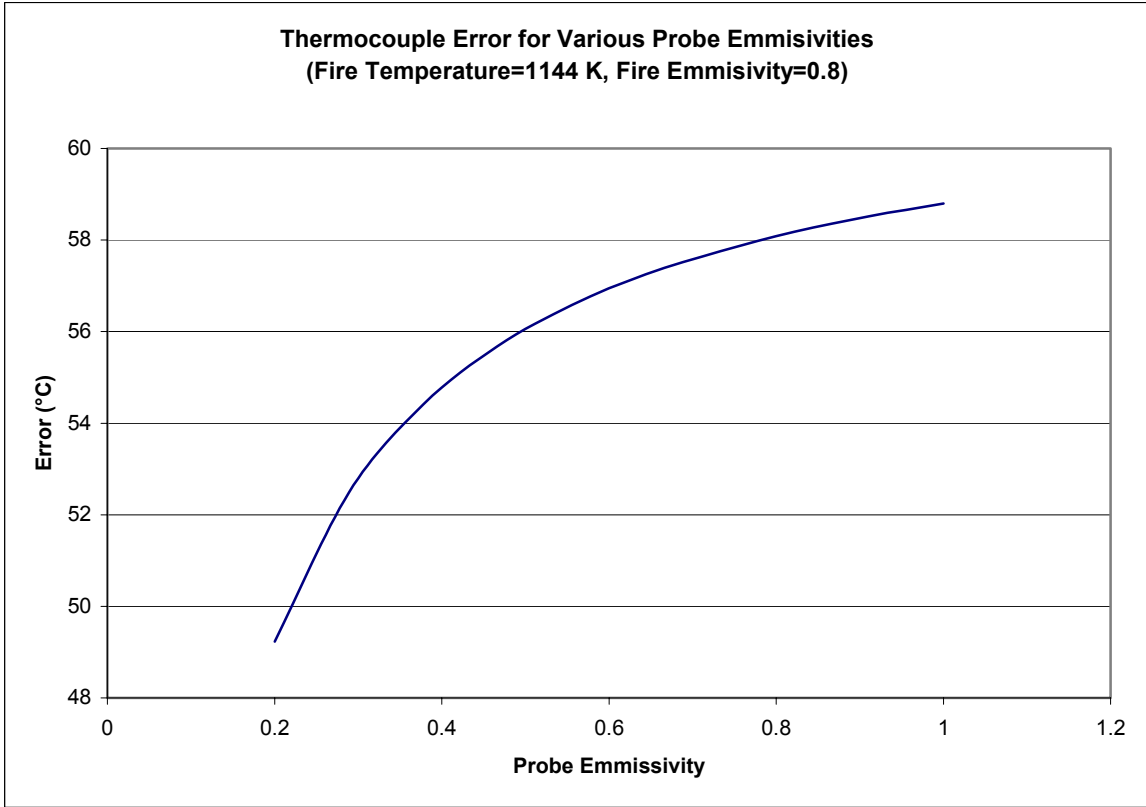
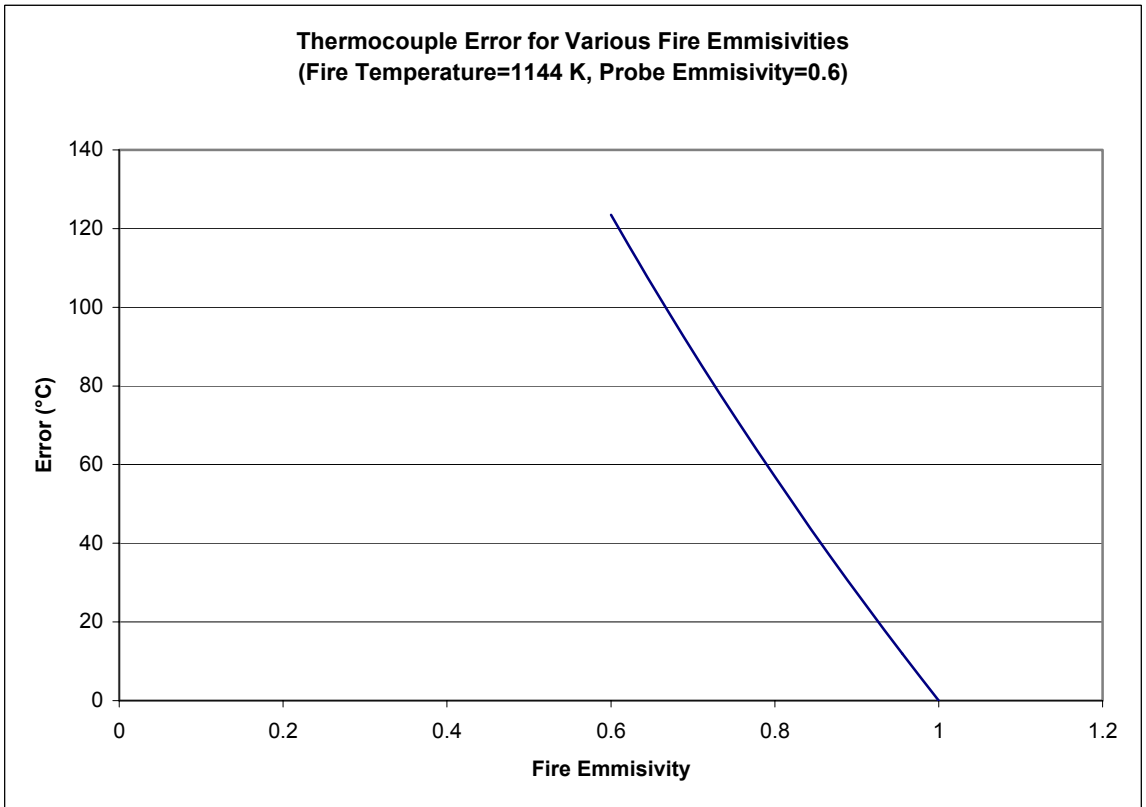
Thermocouple Radiation Error for Various Inputs
